PROJECT SCOPE OF WORK (ALL WORK IS EXTERIOR)

CONTRACT DOCUMENTS

100 YEAR EXTERIOR RENOVATION  
OF THE  
SEATTLE YACHT CLUB MAINSTATION  
1807 East Hamlin Street  
Seattle, Washington 98112

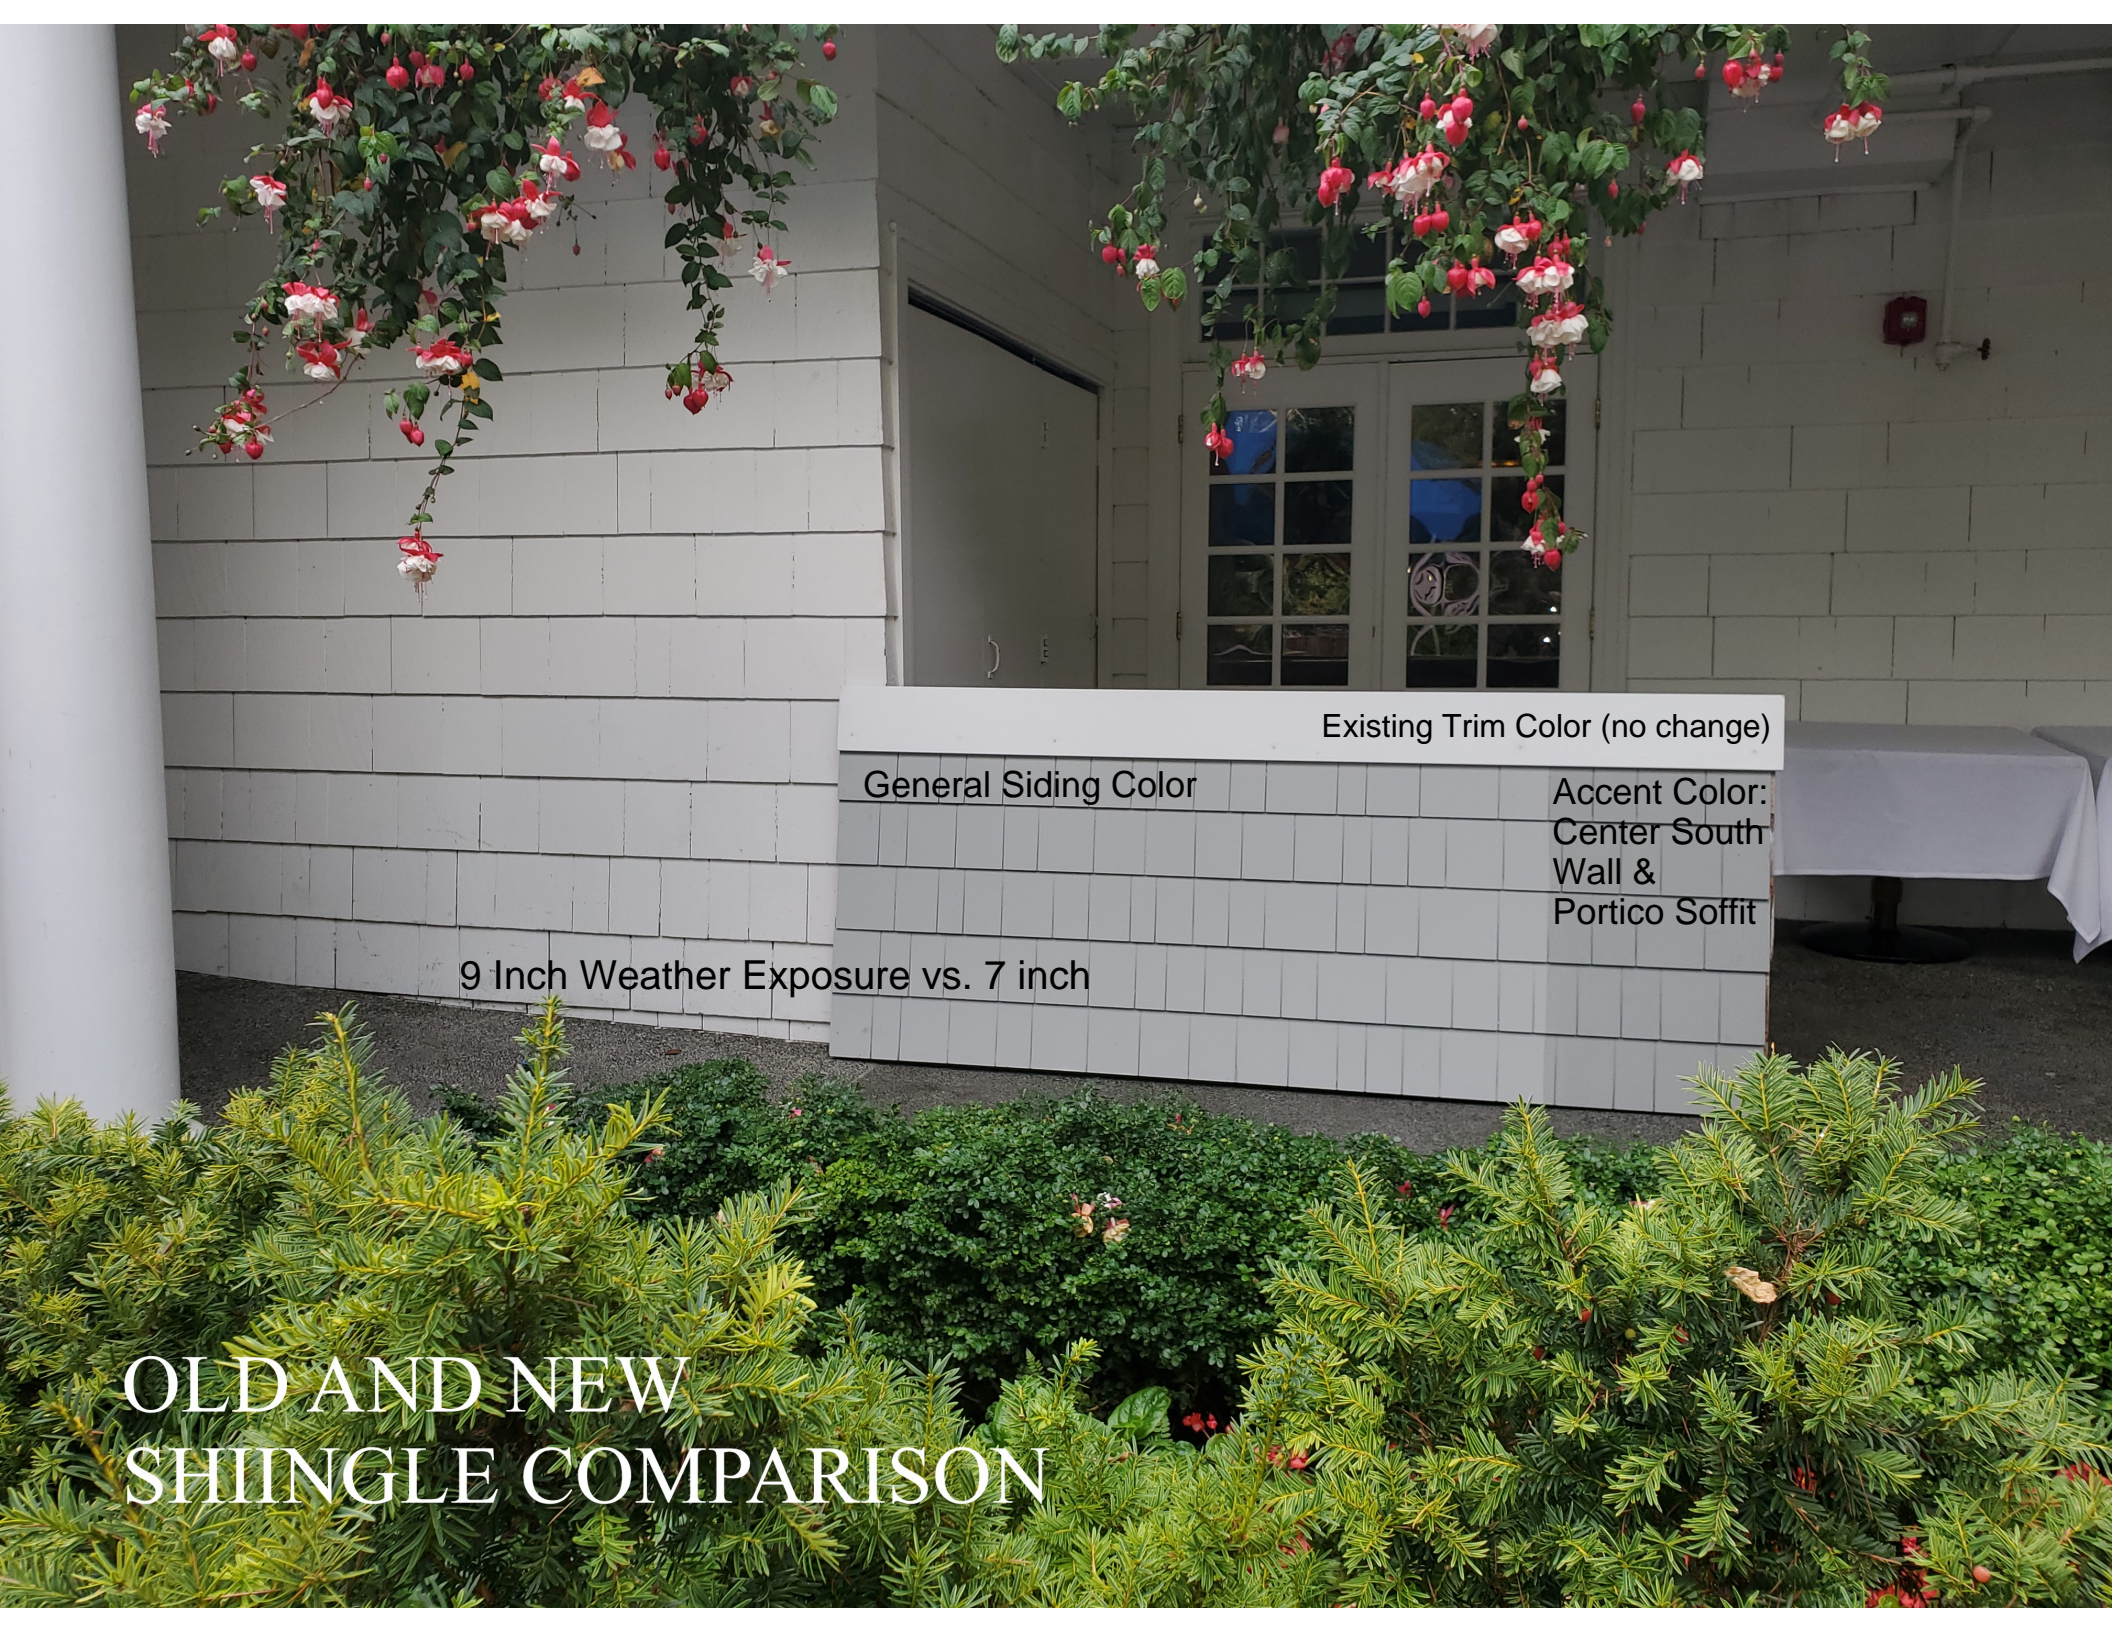
# N O R T H      E L E V A T I O N

Scale:  $1/4'' = 1'-0''$

Existing Trim Color (no change)

General Siding Color

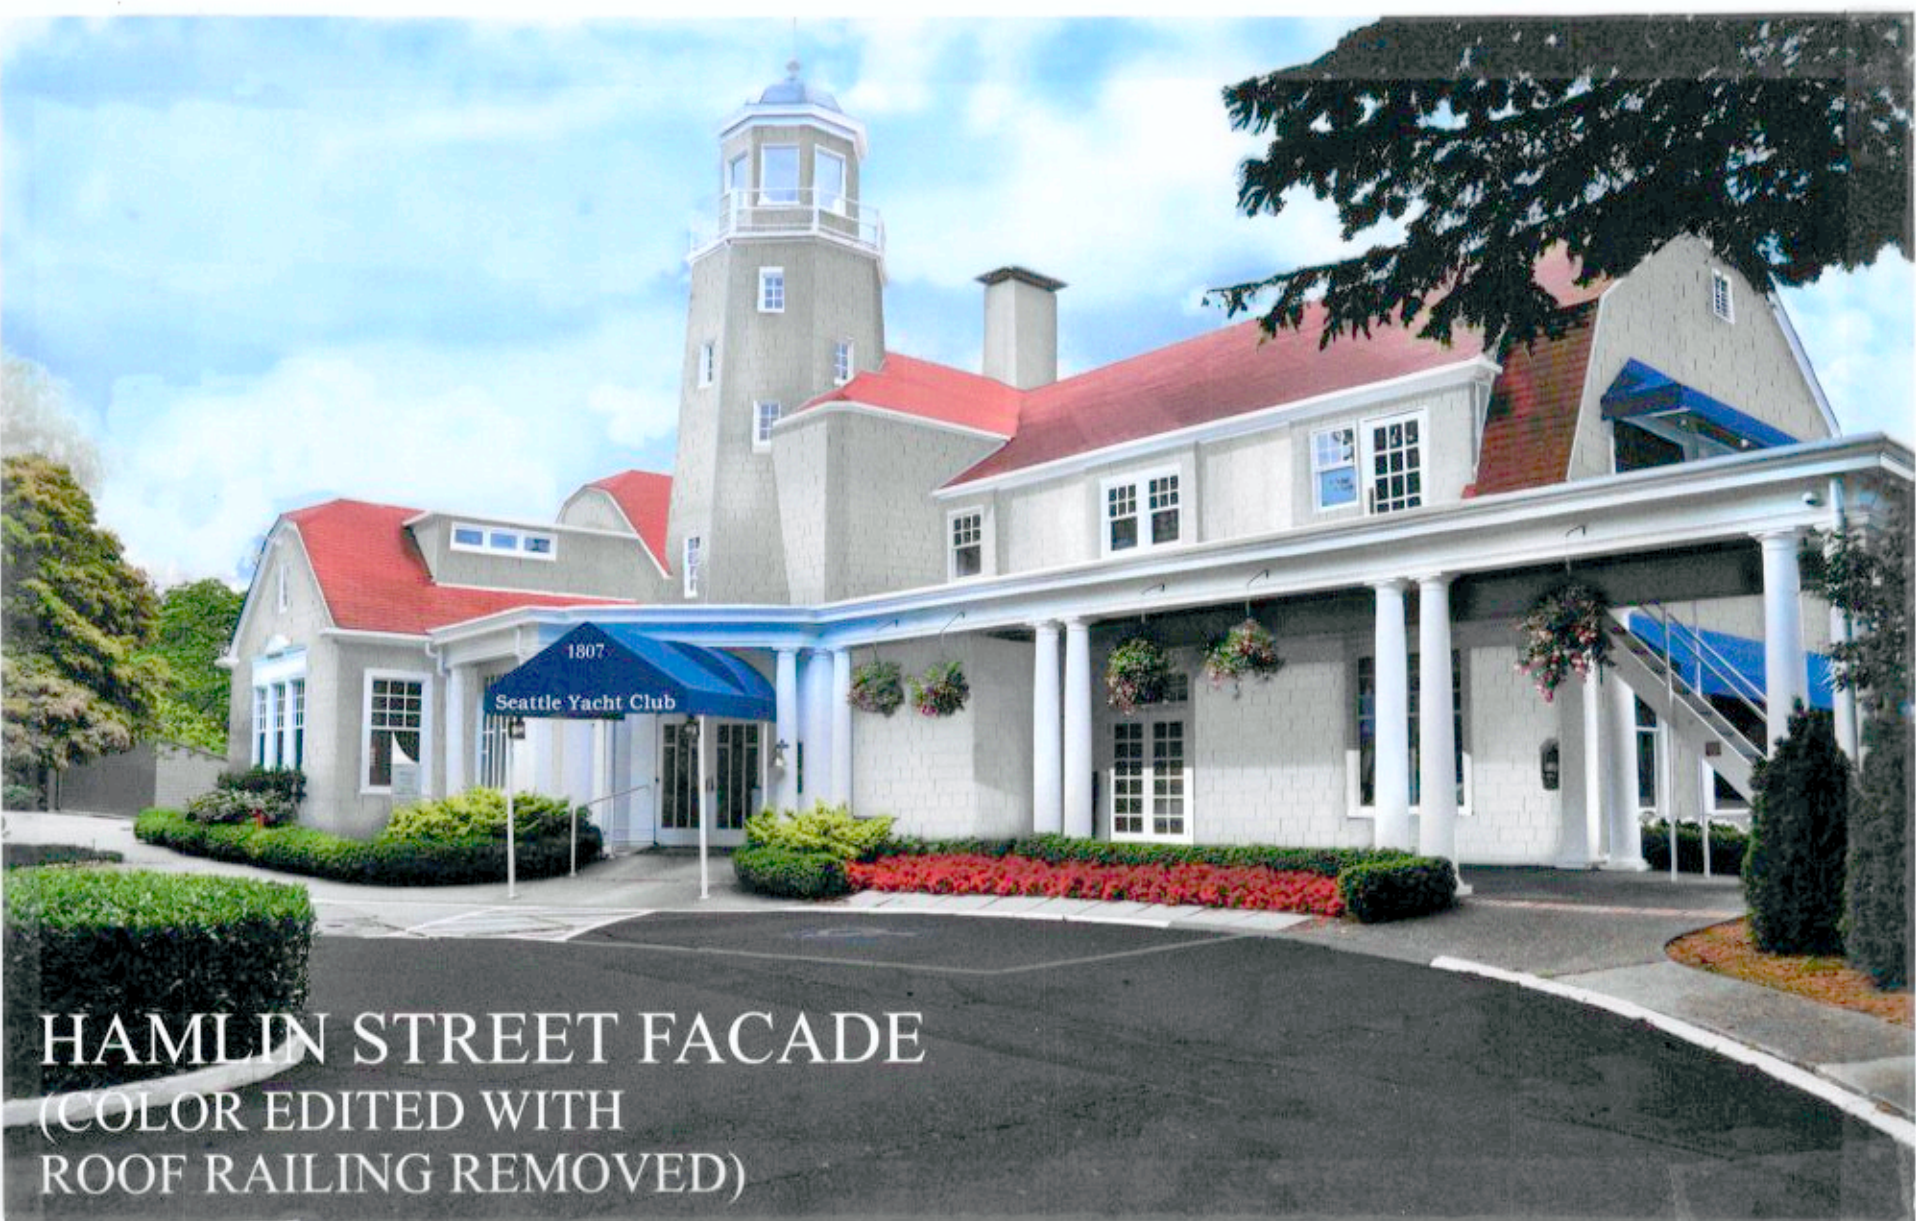
HAMLIN STREET FACADE  
(COLOR EDITED WITH  
ROOF RAILING REMOVED)

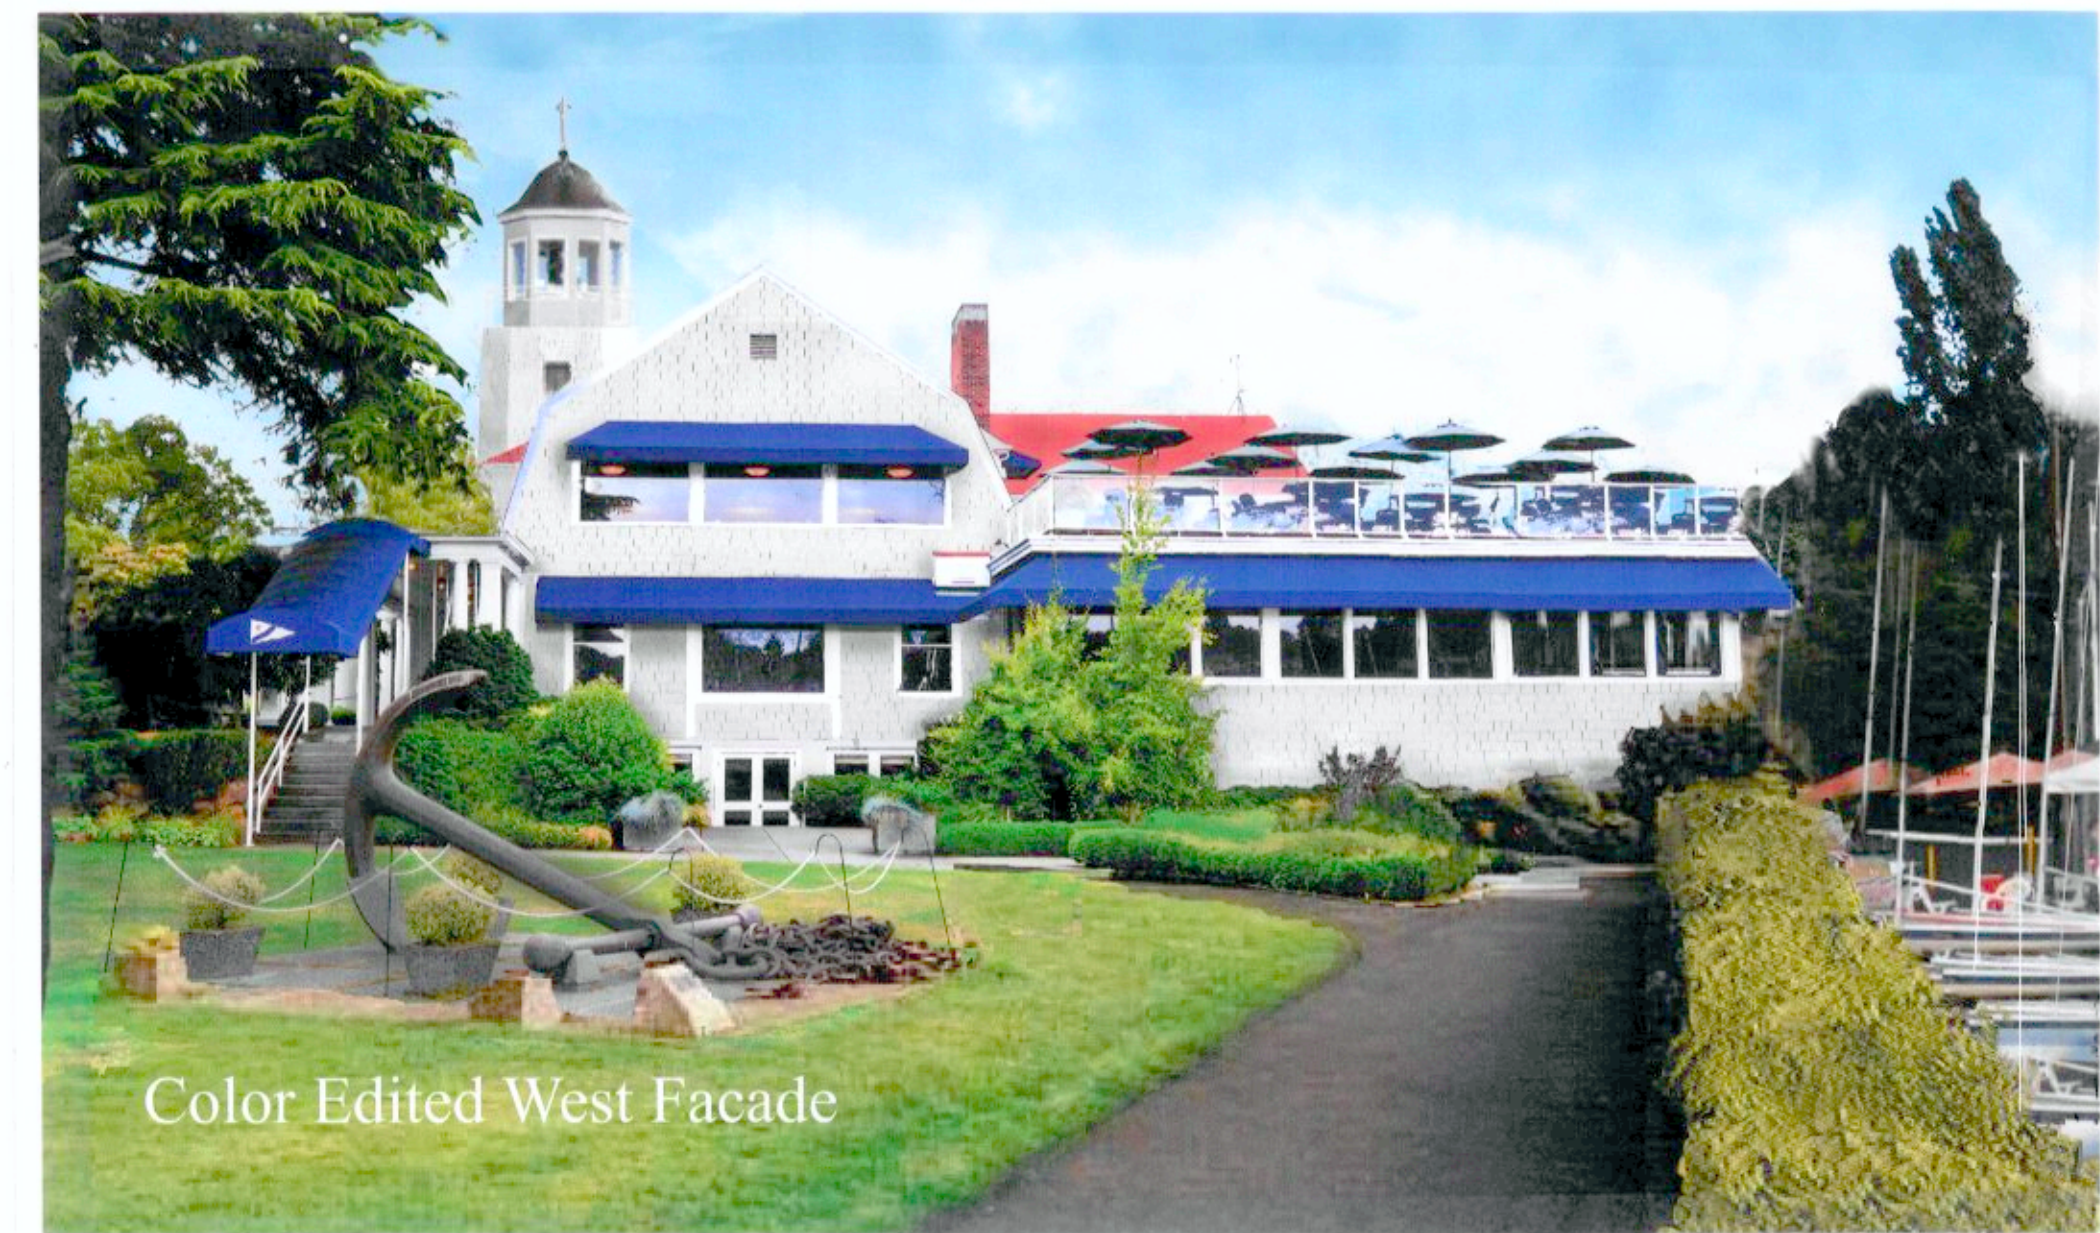
Color Edited West Facade

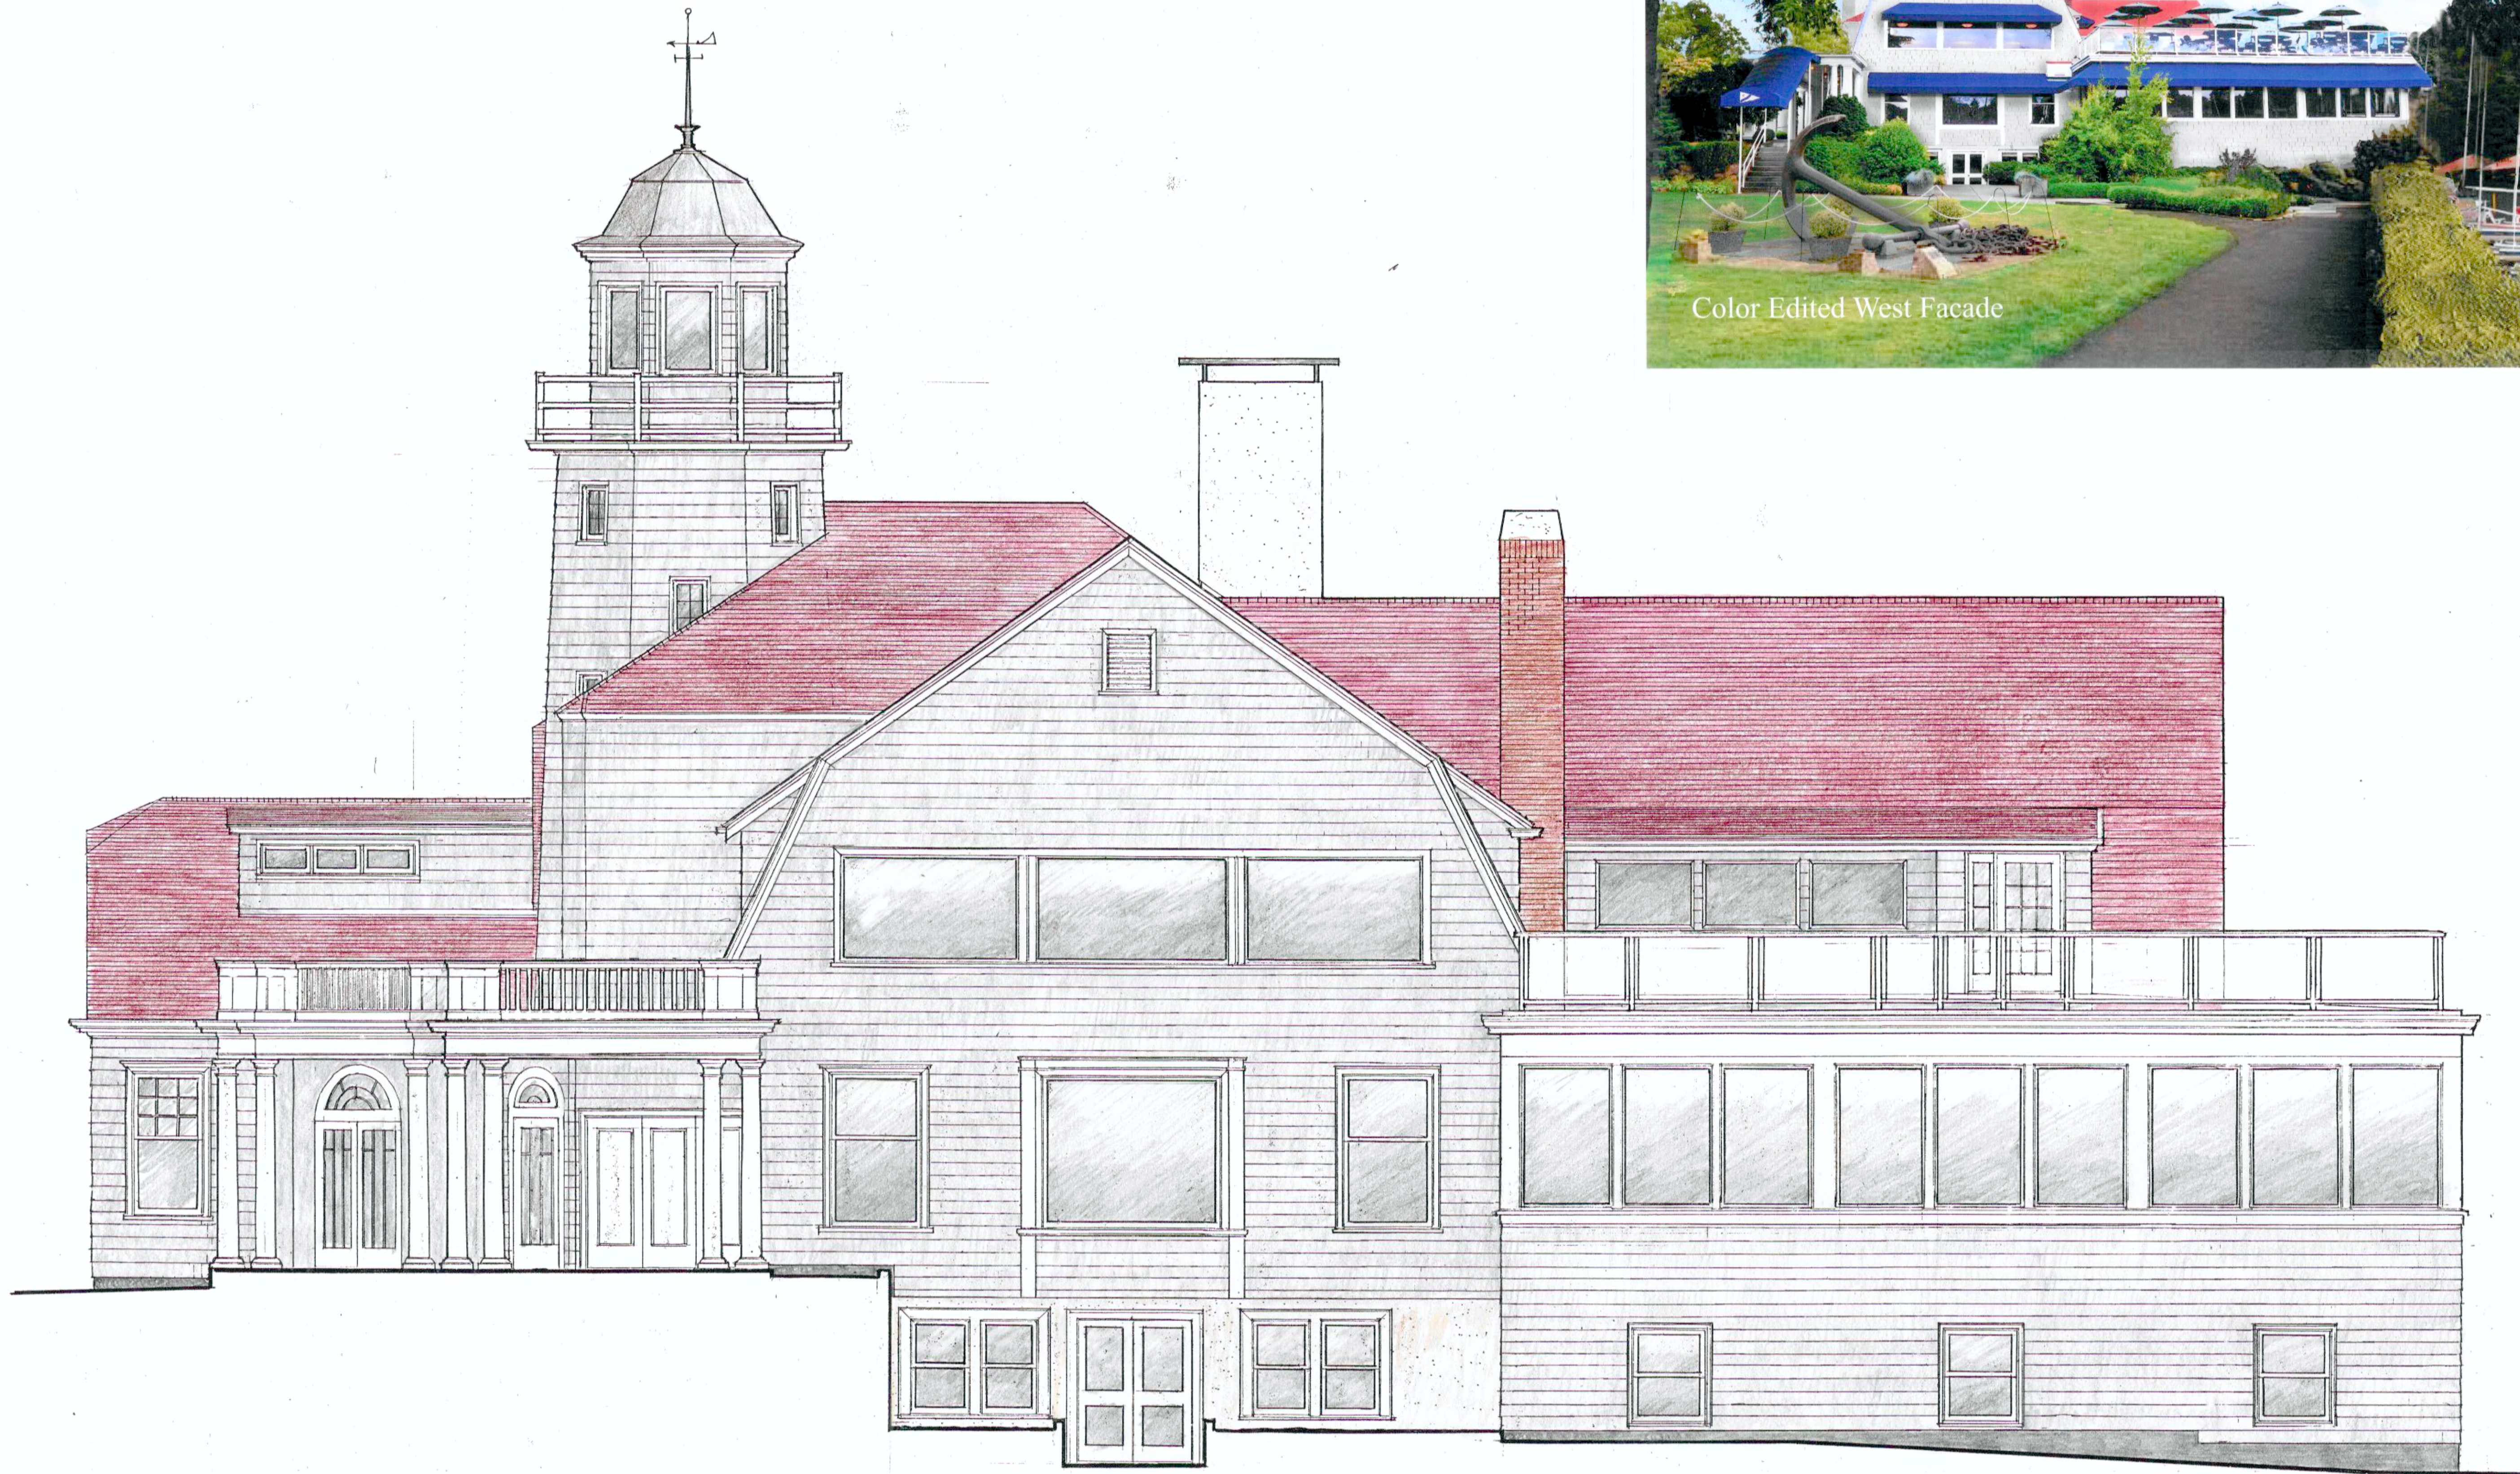
# W E S T E L E V A T I O N

Scale: 1/4" = 1'-0"

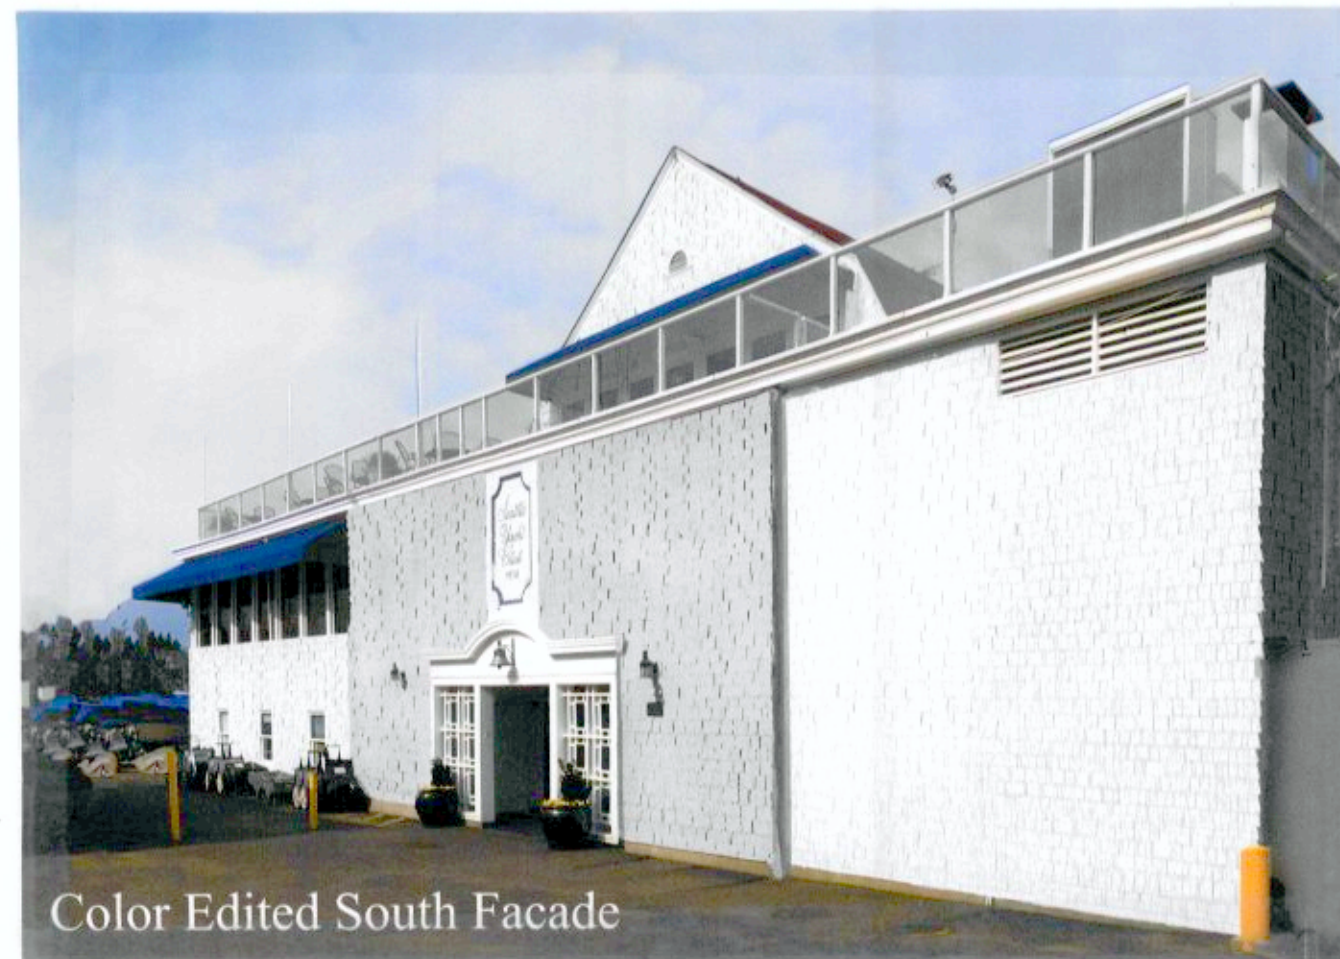
Color Edited South Facade

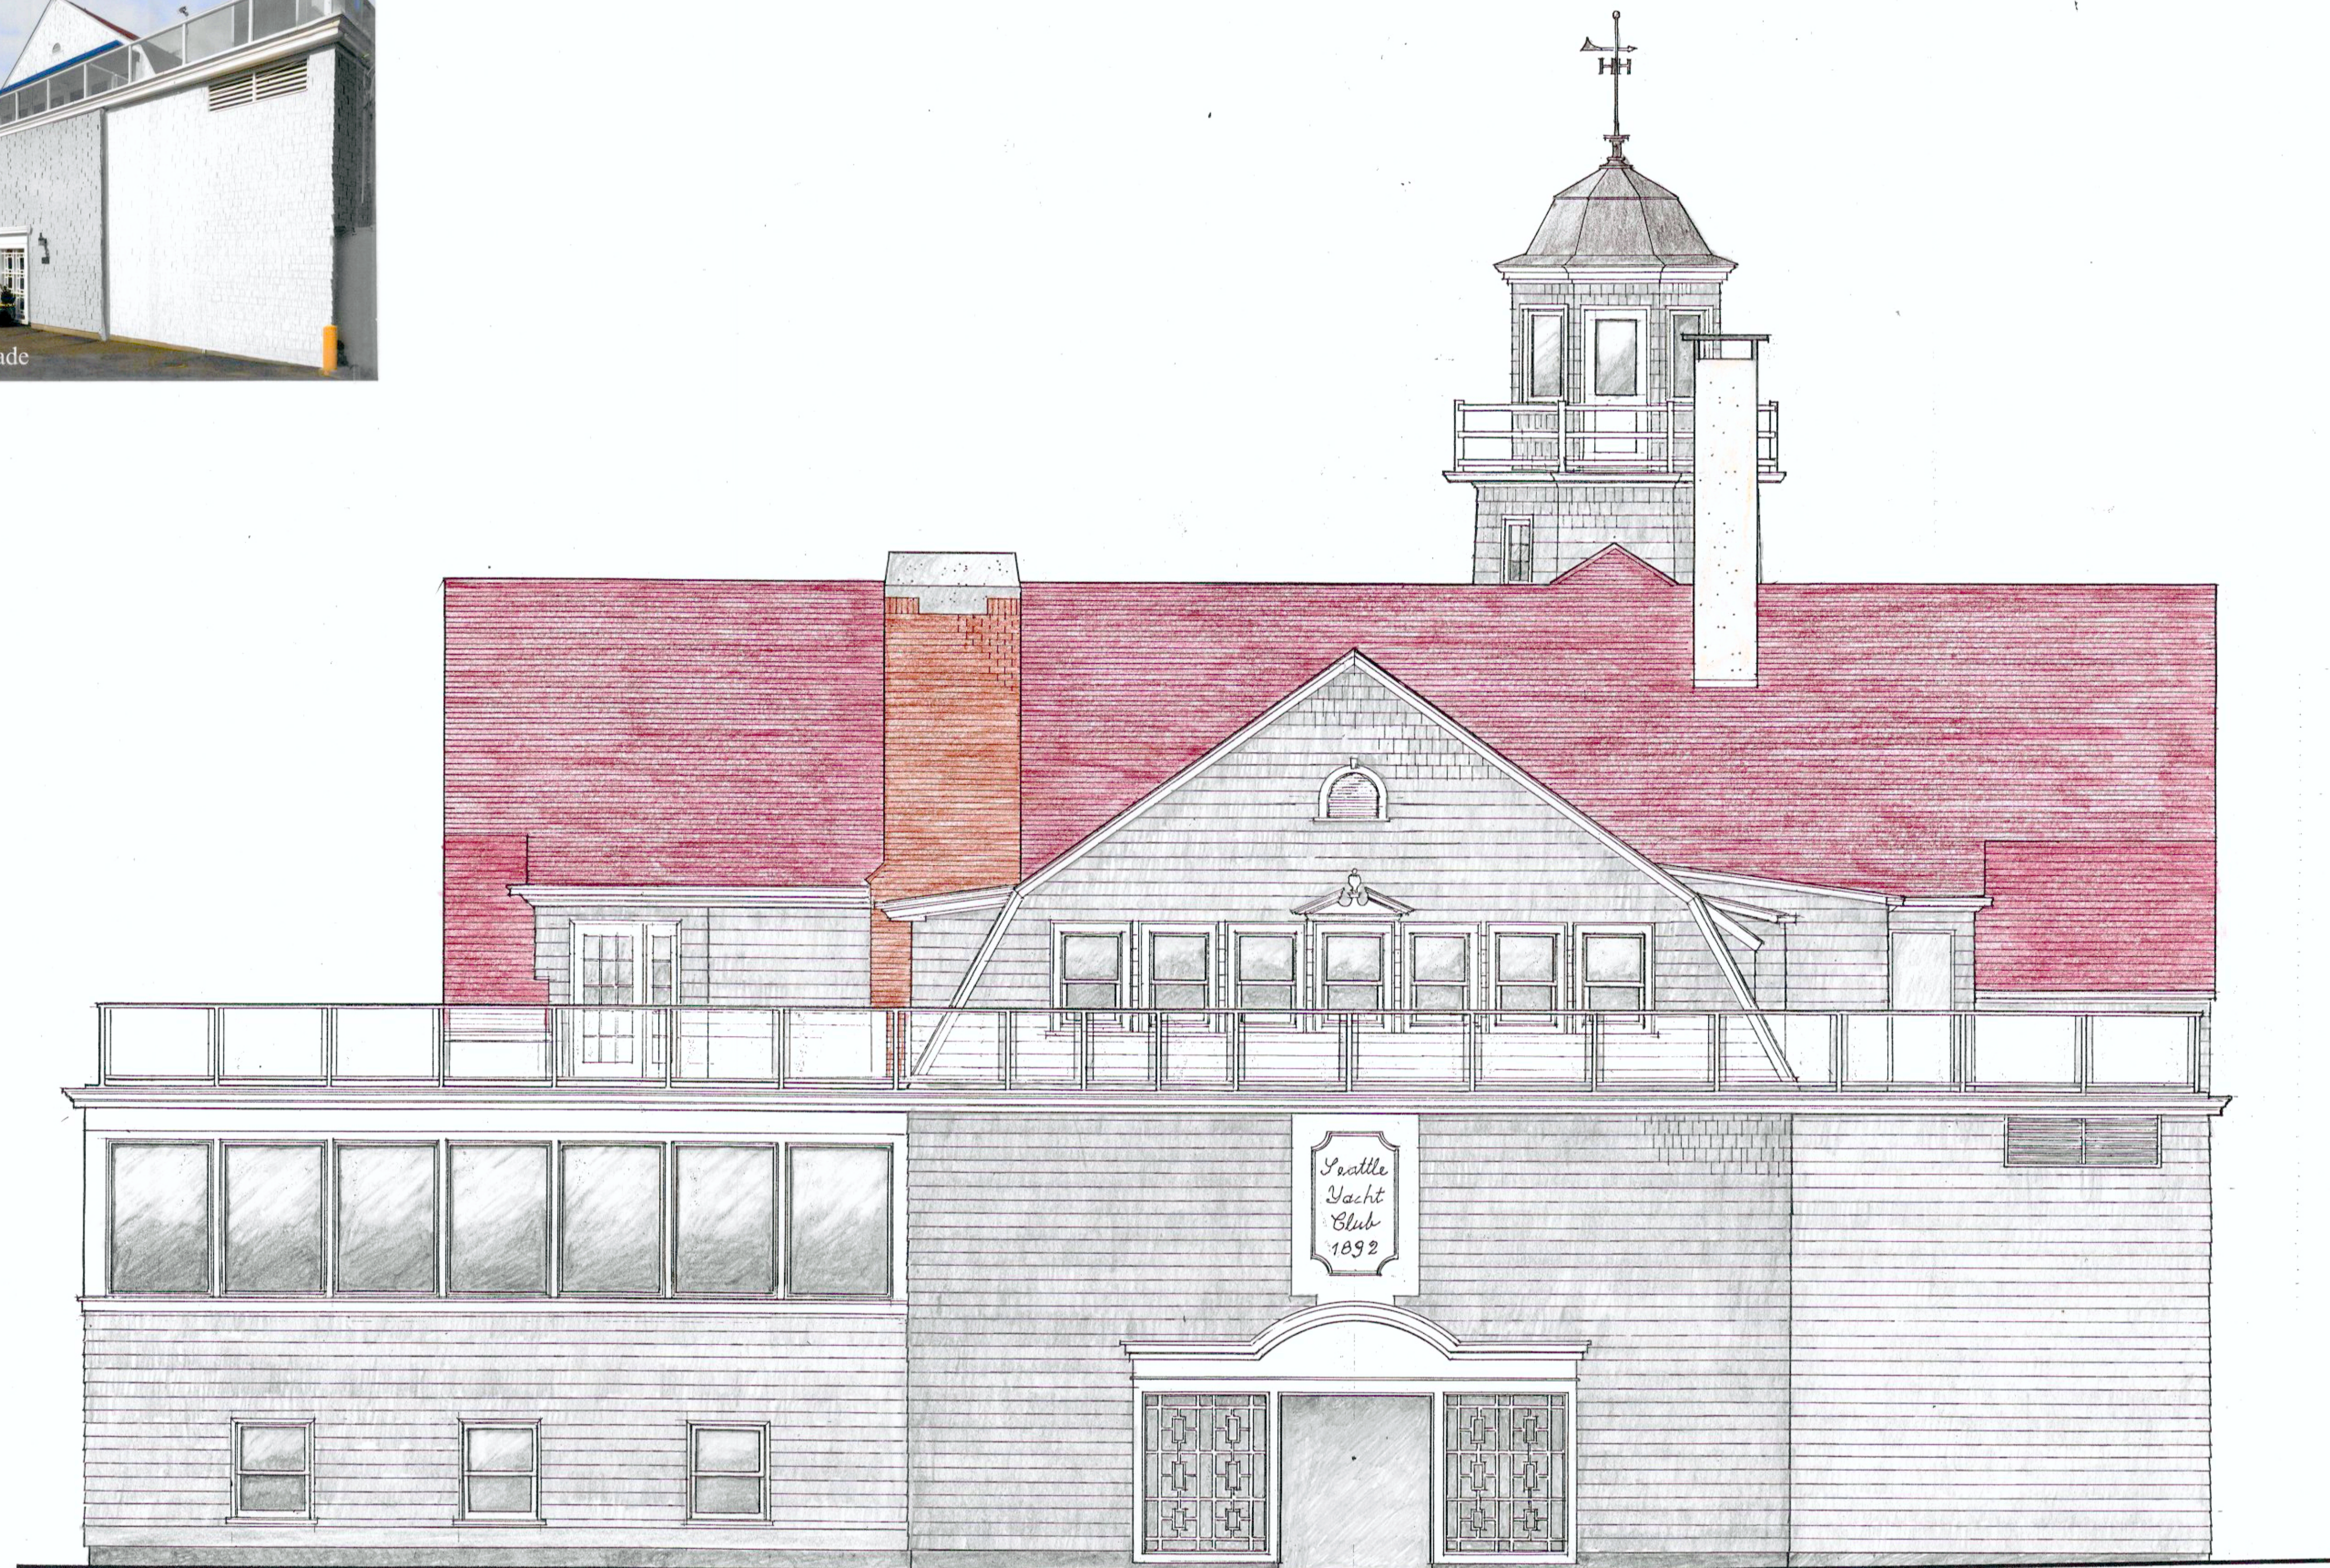
# S O U T H E L E V A T I O N

Scale: 1/4" = 1'-0"

EXISTING STUCCO  
CHIMNEY

EXISTING ASPHALT  
COMP. ROOFING, TYPICAL

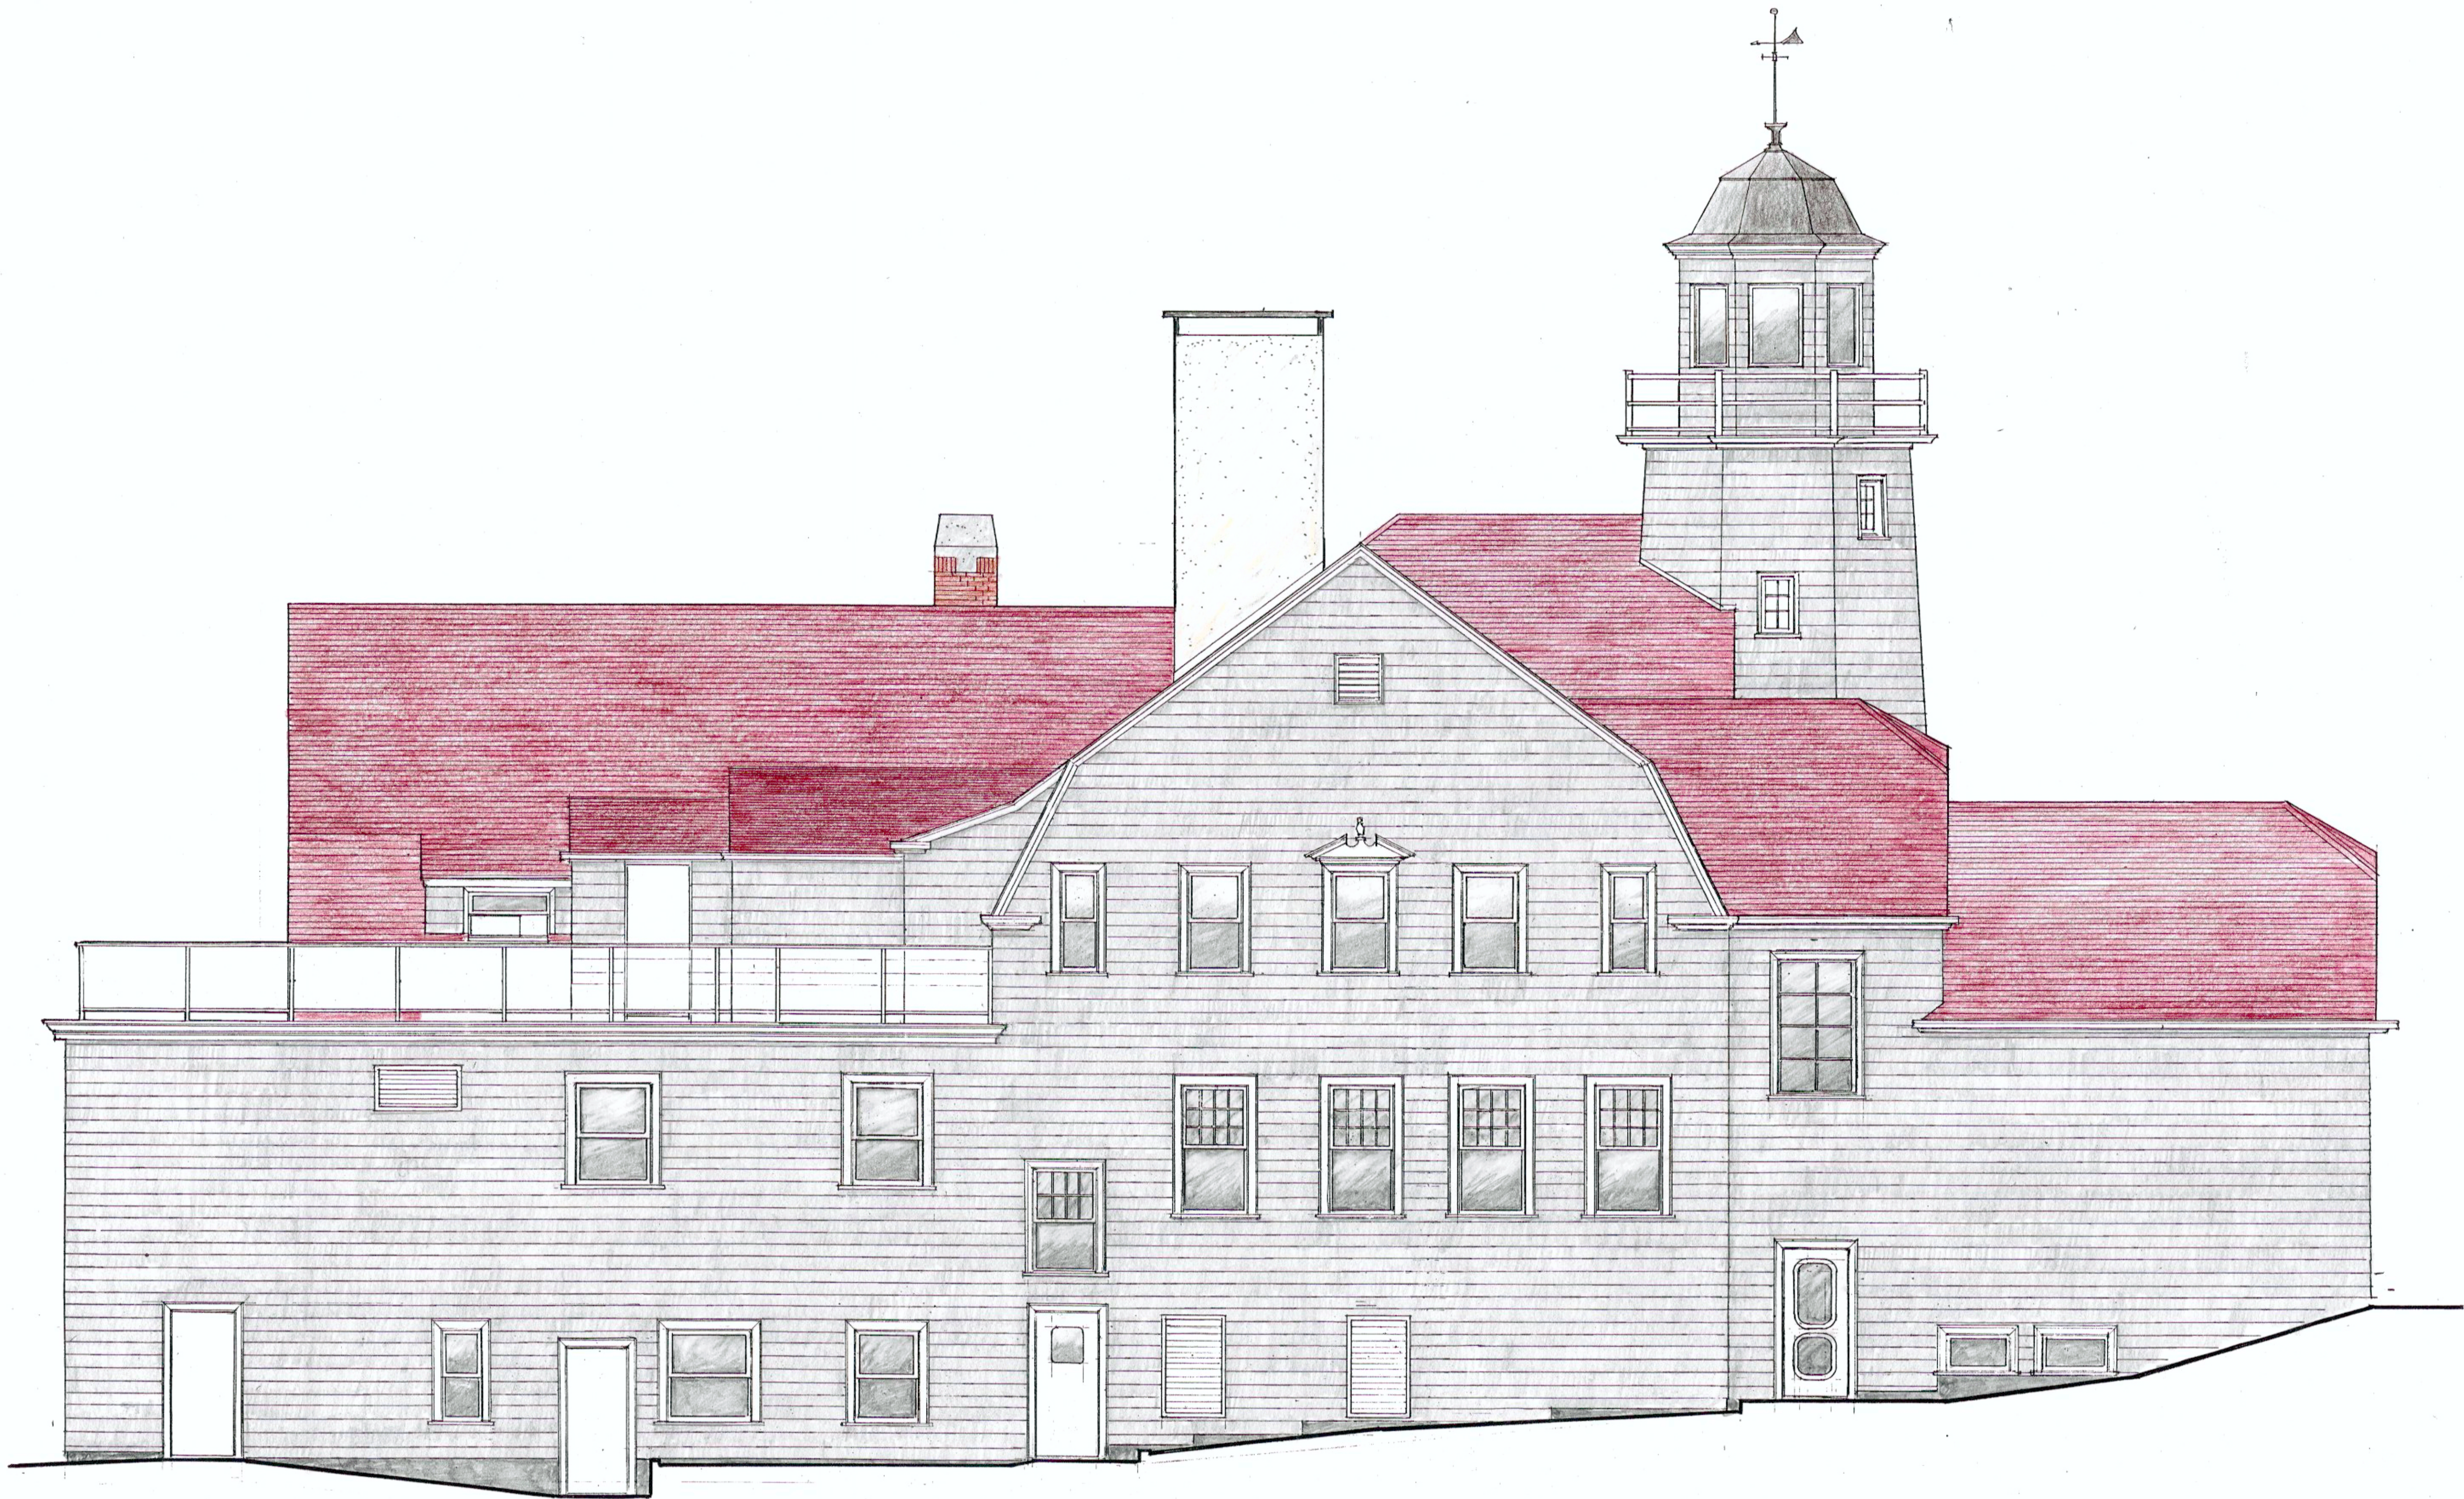
**E A S T E L E V A T I O N**

Scale: 1/4" = 1'-0"
